Trouble Shooting Guide

R&D Center

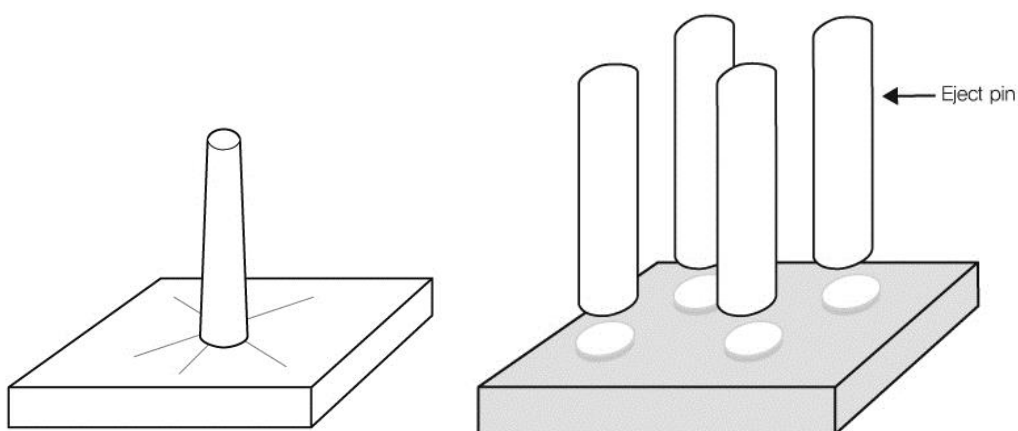
| Classification | Causes | Suggested remedies |

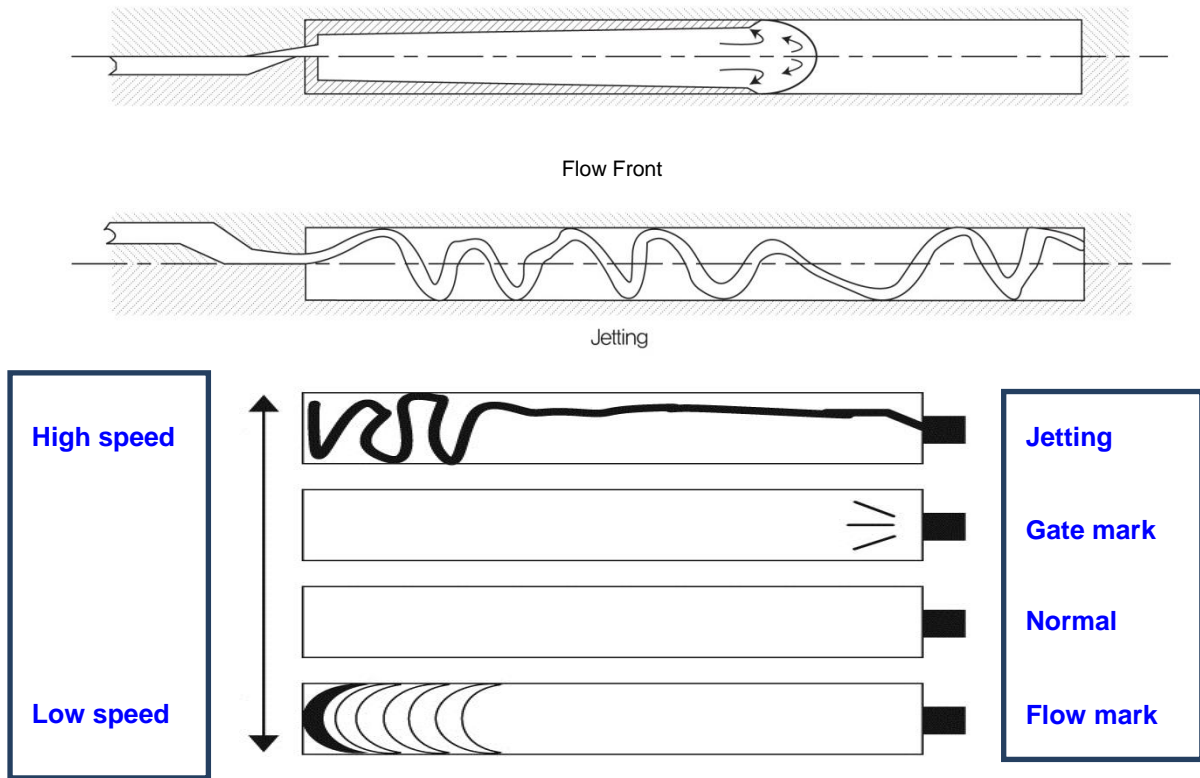
| Classification | Causes | Suggested remedies |

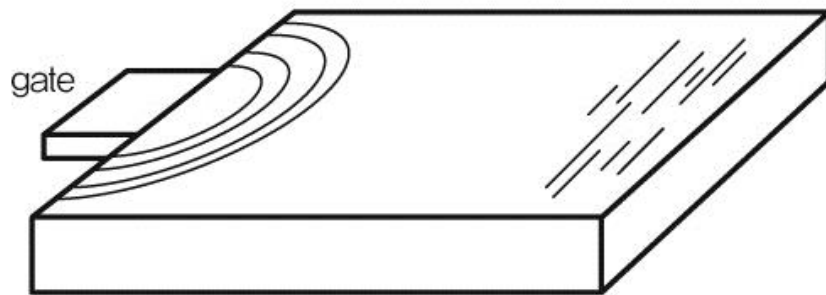
Procedure of Flow Marks

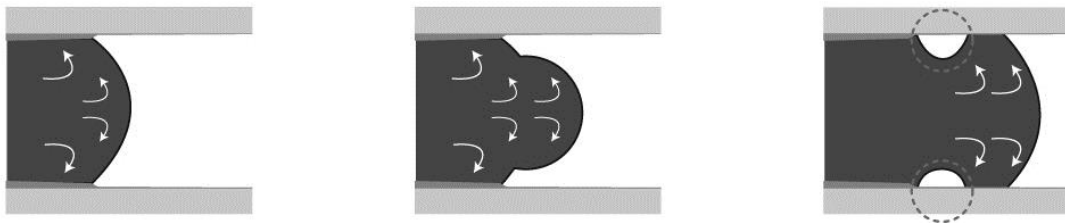
| Classification | Causes | Suggested remedies |

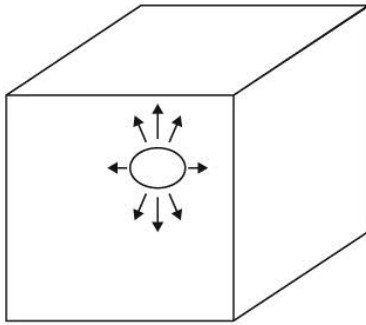
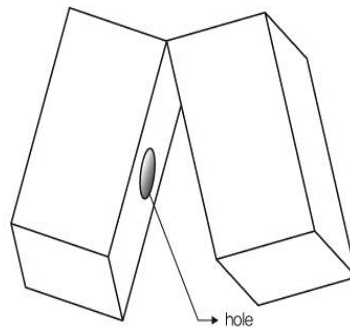
| Classification | Causes | Suggested remedies |

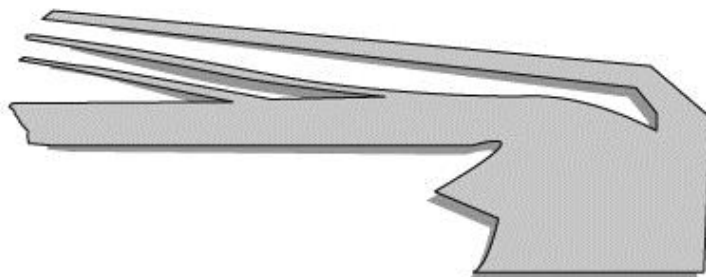
| Classification | Causes | Suggested remedies |

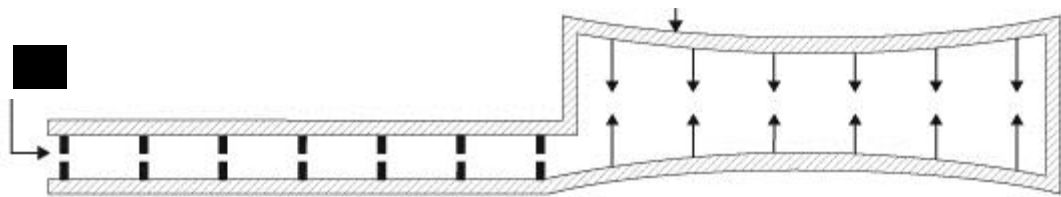
| Classification | Causes | Suggested remedies |

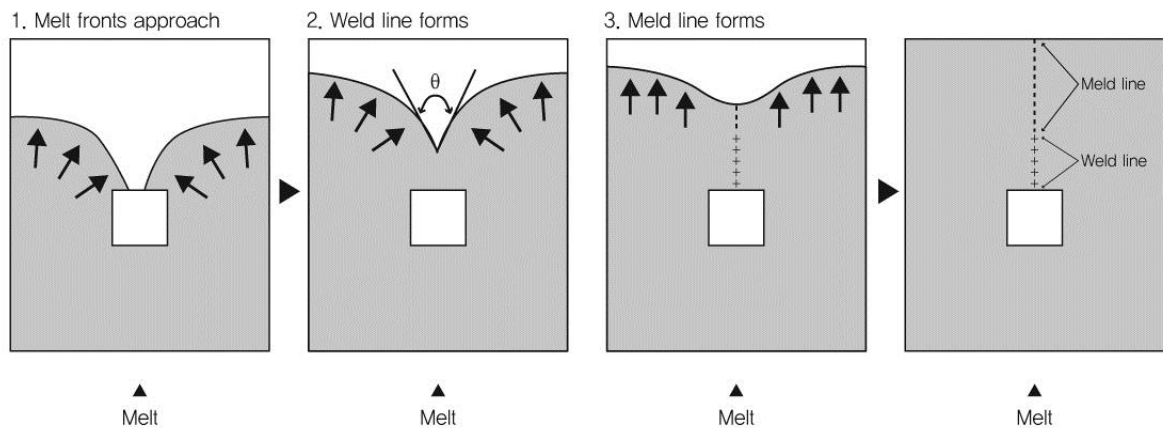
| Classification | Causes | Suggested remedies |

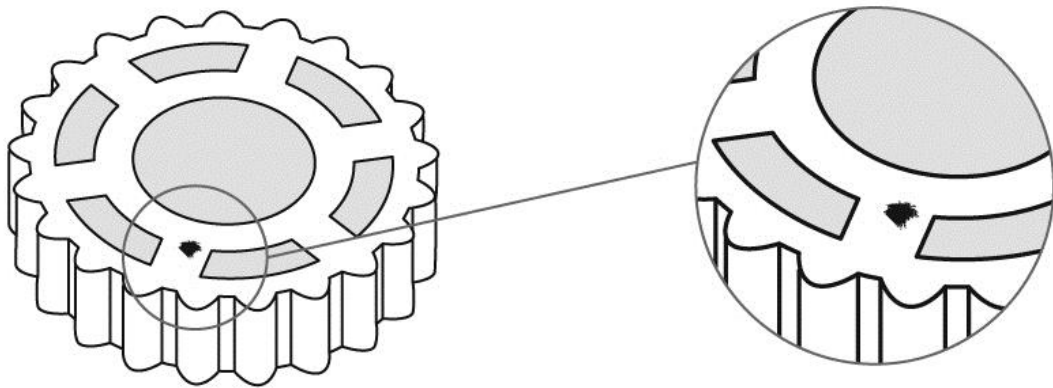
| Classification | Causes | Suggested remedies |

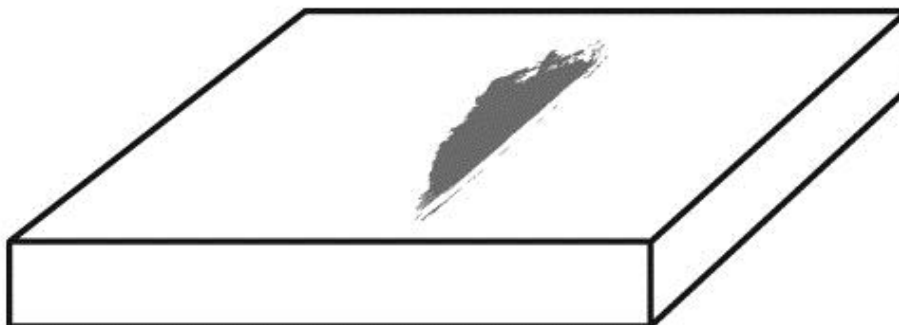
| Classification | Causes | Suggested remedies |

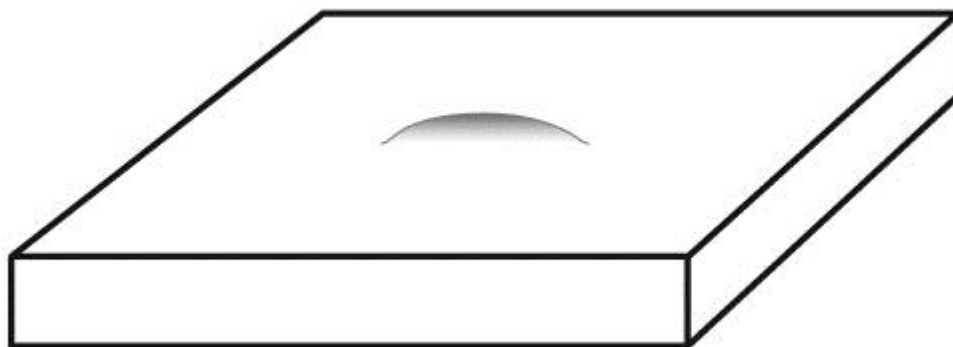
| Classification | Causes | Suggested remedies |

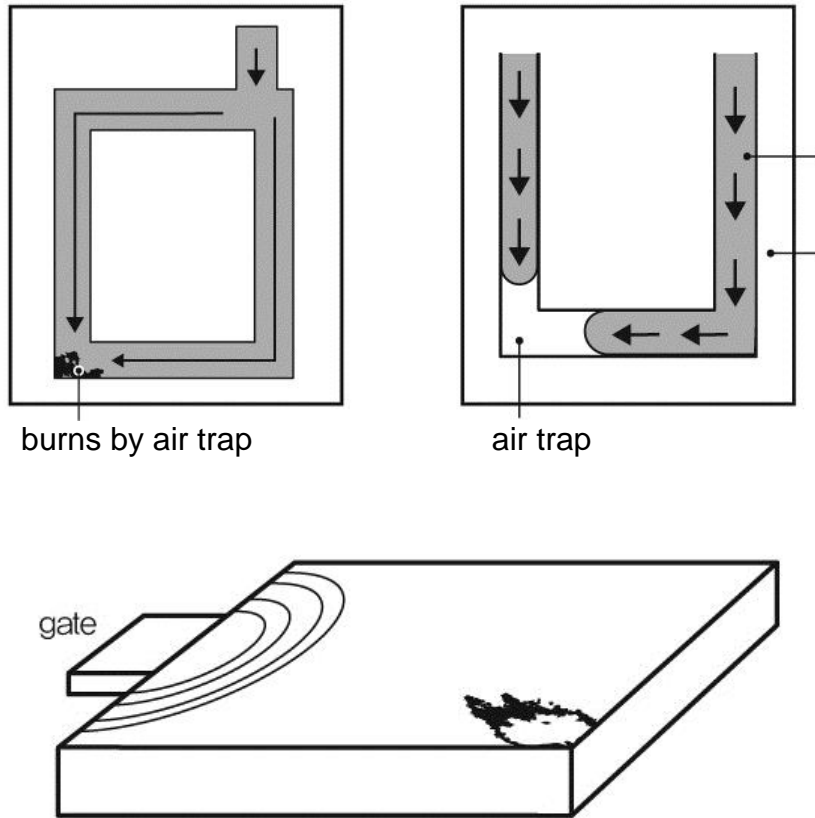
| Classification | Causes | Suggested remedies |

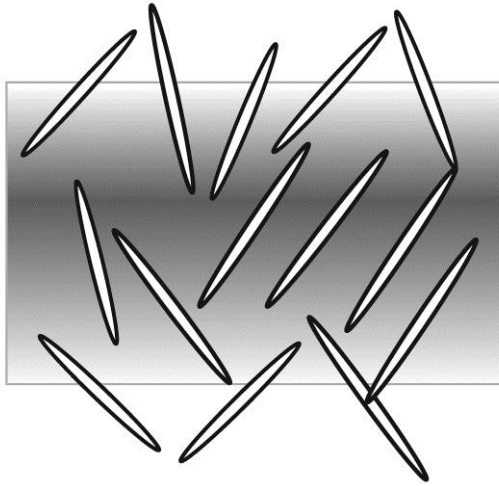
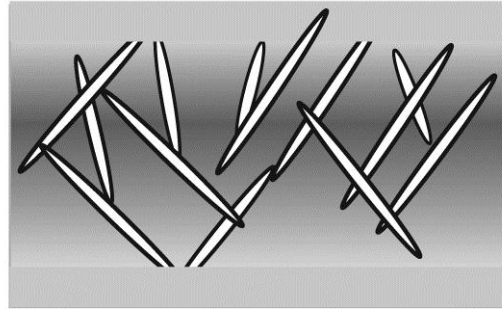
| Classification | Causes | Suggested remedies |

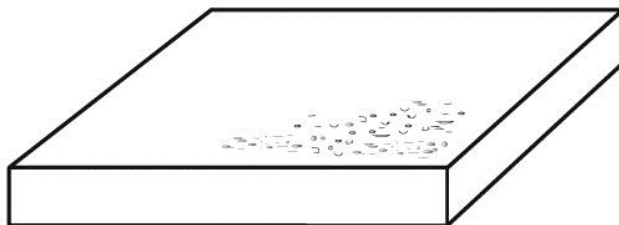
| Classification | Causes | Suggested remedies |
